Mass Timber Buildings Moisture Monitoring and Management
A Comparative Study of Building Types, Design Techniques, and
Climate Conditions for Enhanced Protection Plans and Best
Practices

Dr Maryam Shirmohammadi
Gottstein Fellowship Final Report
October 2025

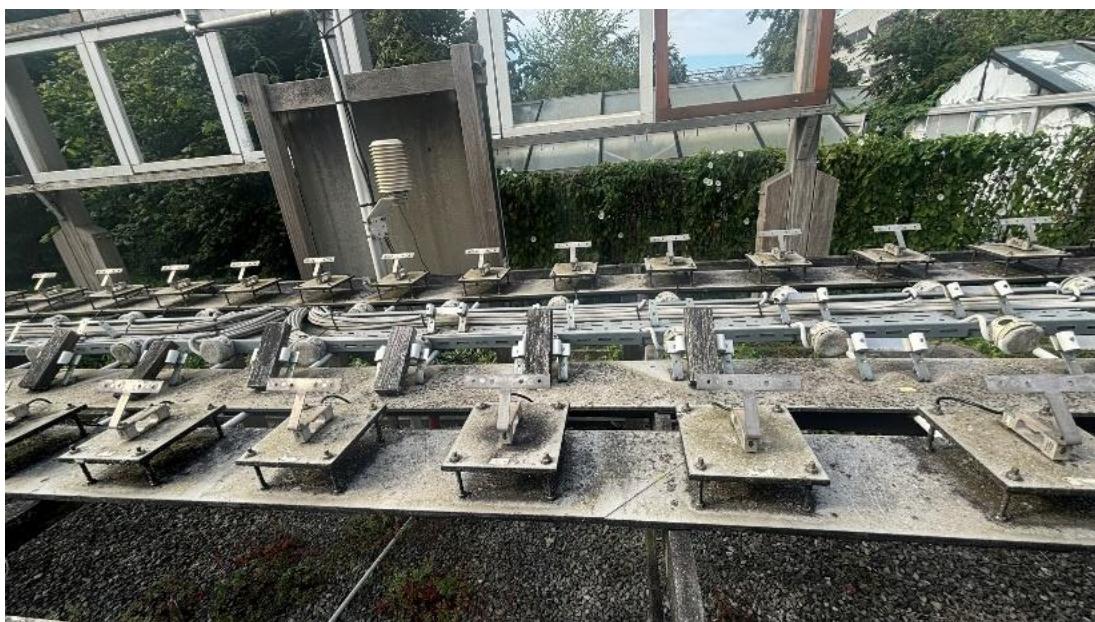
Figure 7: Field trial set up at the University of Ghent monitoring continuous moisture changes of timber sections exposed to weather.

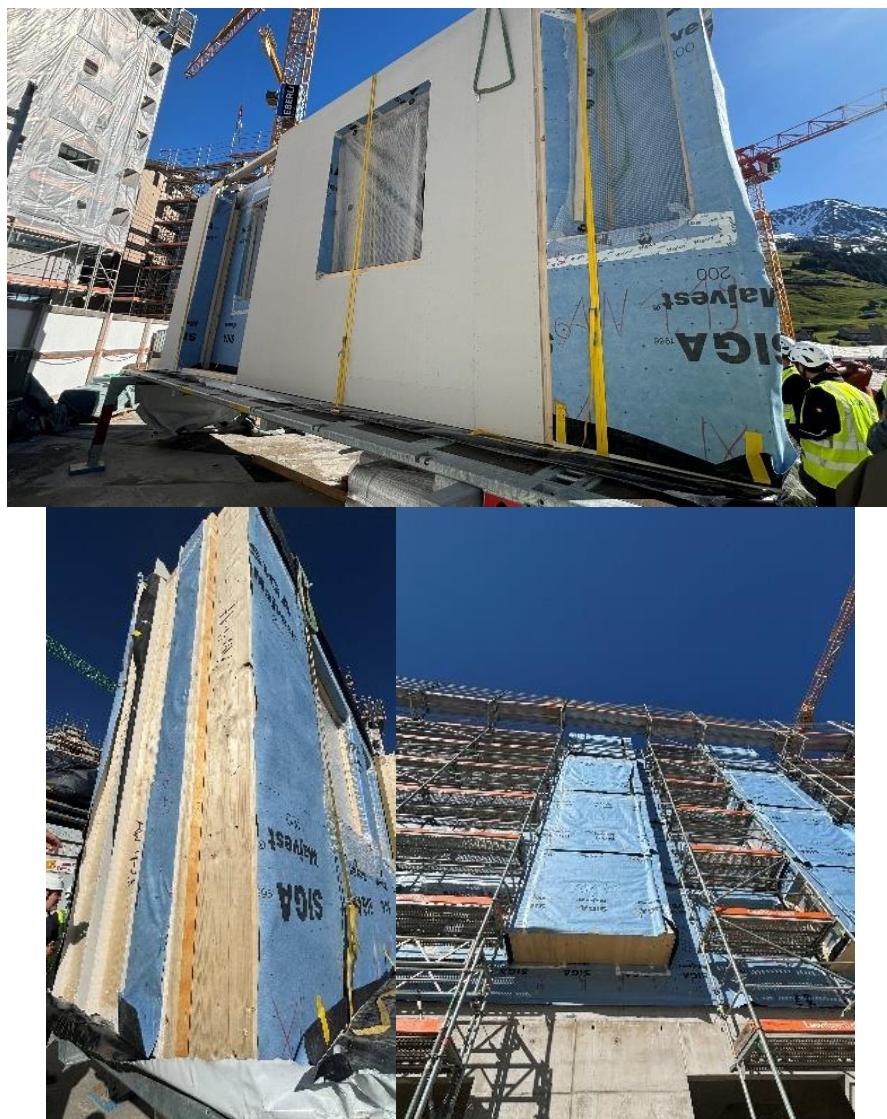
Figure 8: Prefabricated building sections arriving at site protected for any weather change and moisture exposure, Switzerland.

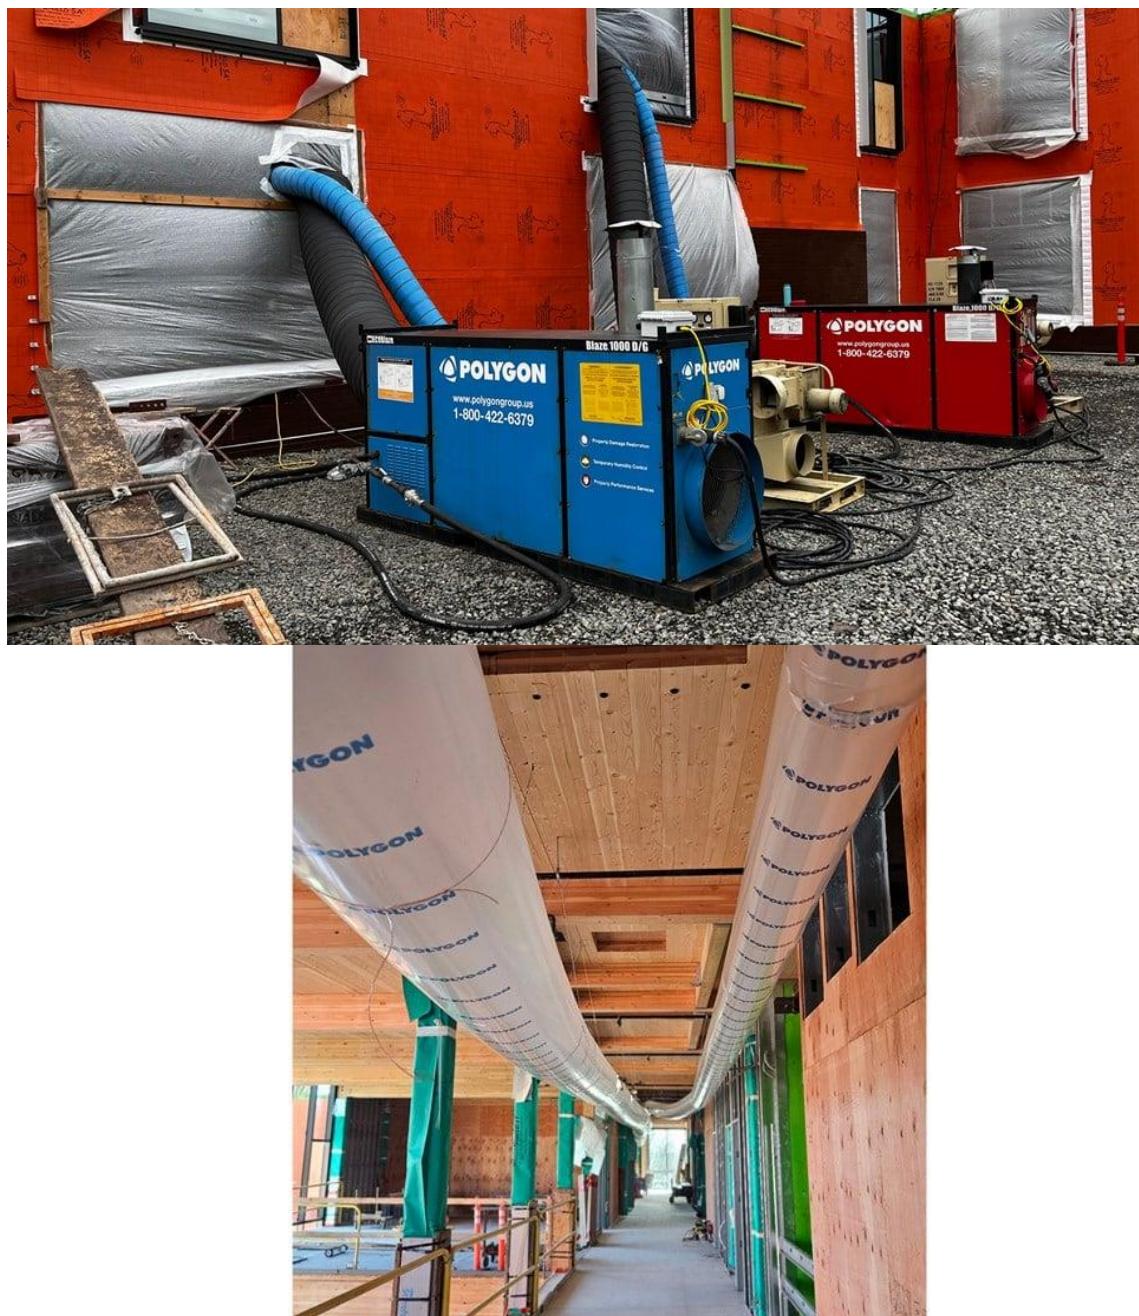
Figure 10: Example of drying process on construction site focused on reducing moisture content using desiccant drying (top) and tunnel fan drying (bottom) [51].

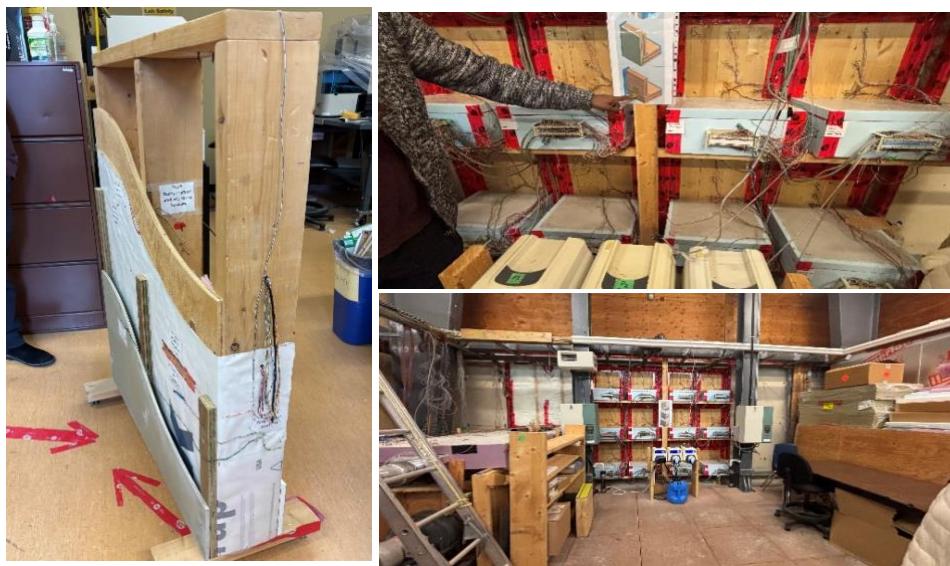
Figure 11: Laboratory study of building sections exposed to various moisture scenarios.

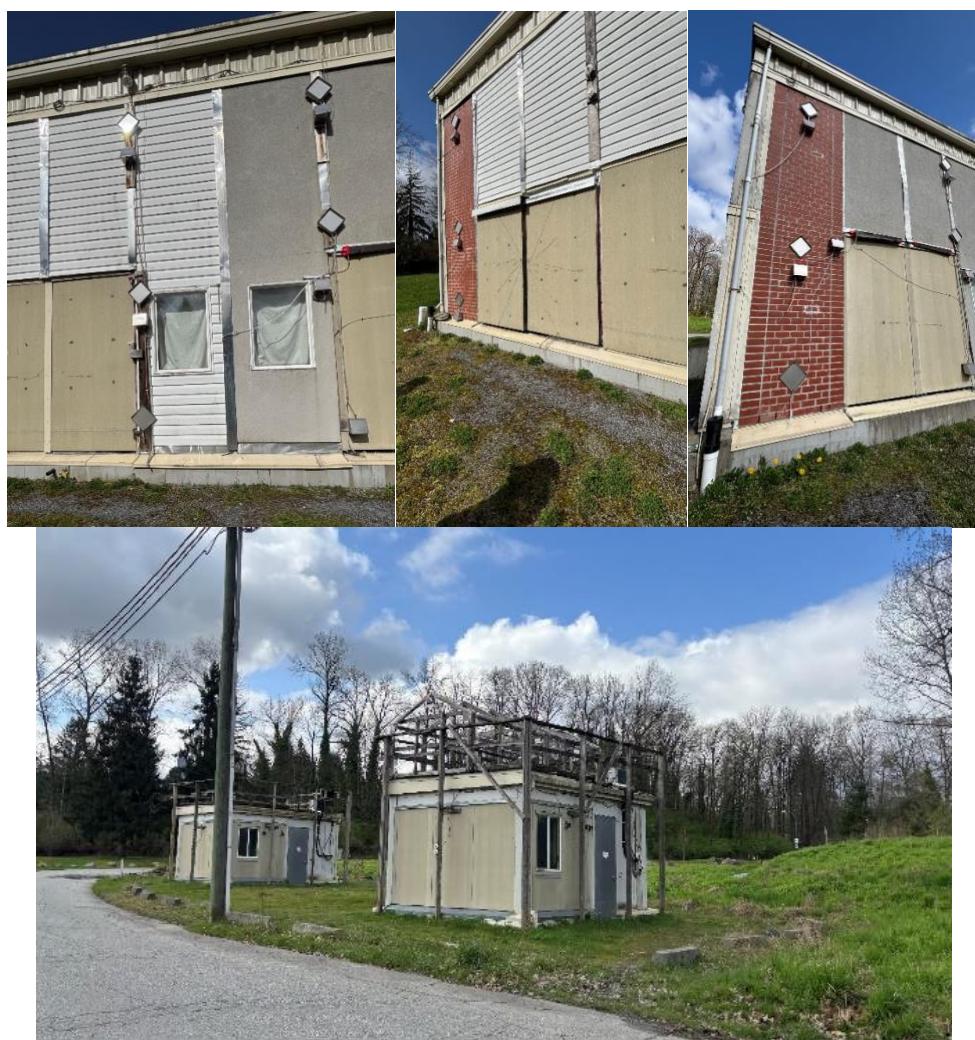
Figure 12: Large scale testing of timber building section set up with different layer up exposed to post-construction (leak/condensation) moisture.

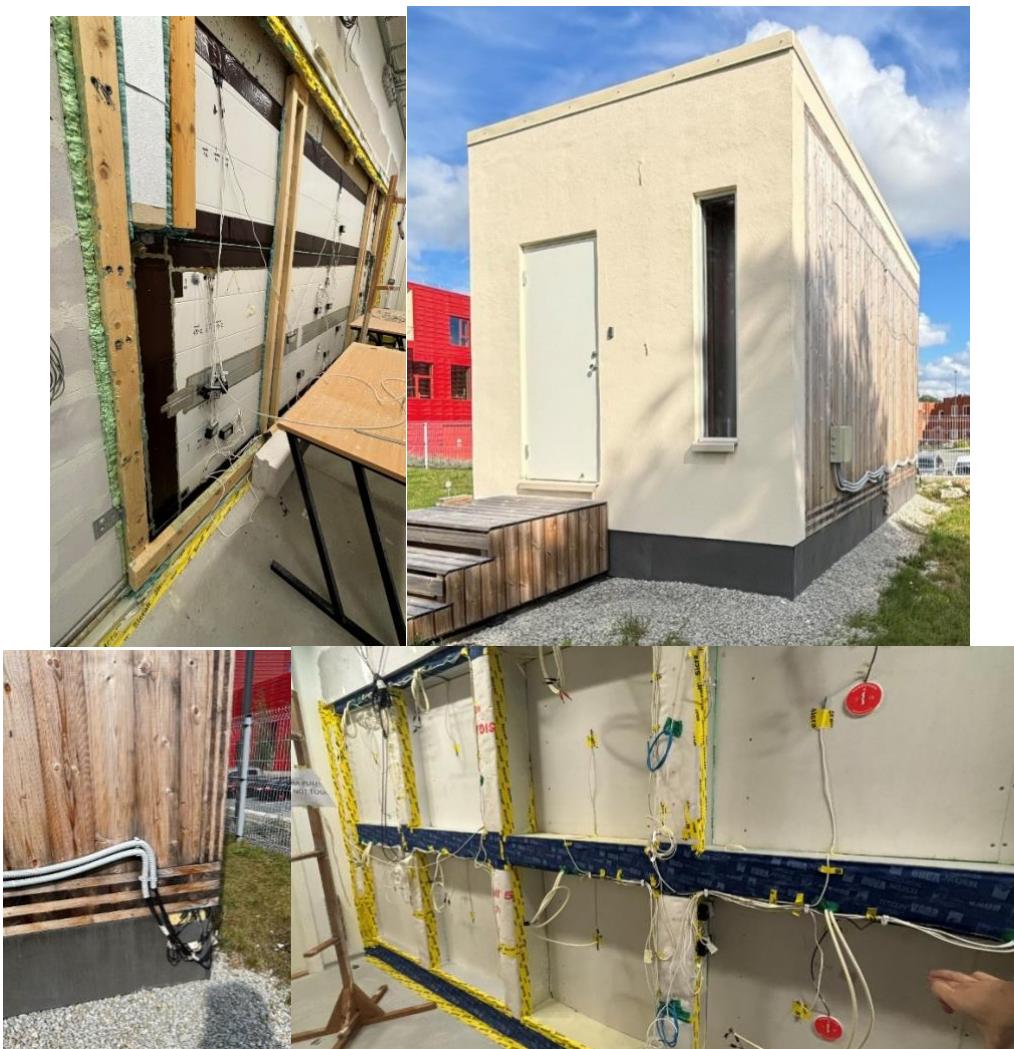
Figure 13: Large scale experimental set up at TalTech testing the moisture changes in timber structures (CLT and timber framing) using real-time data collection.

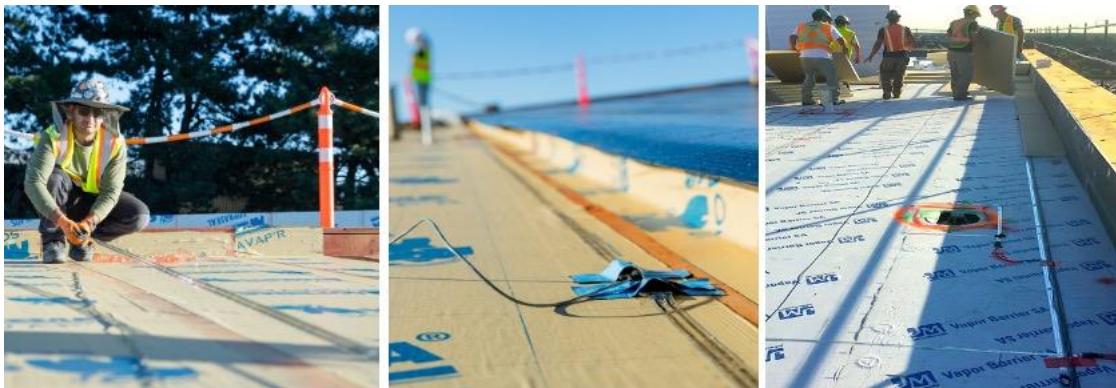
Figure 15: Leak detection systems applied on outer surface of roofing.

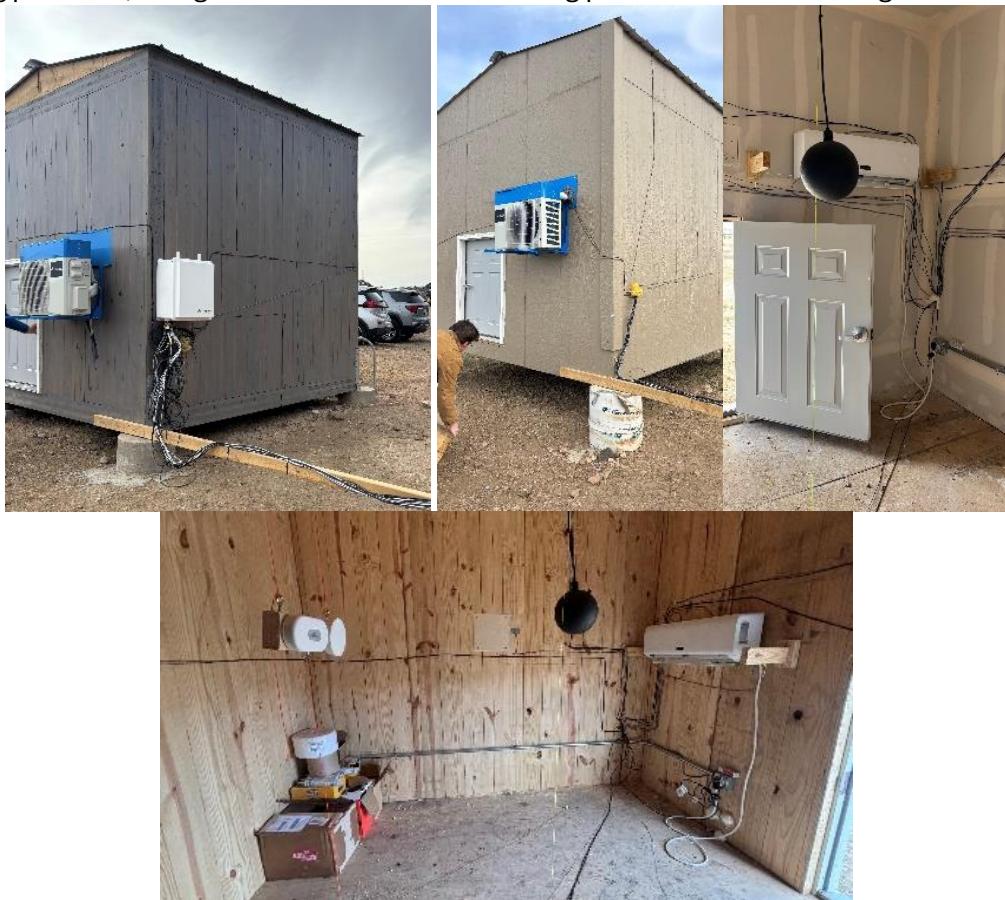
Figure 17: Internal building condition monitoring of different design and layer up

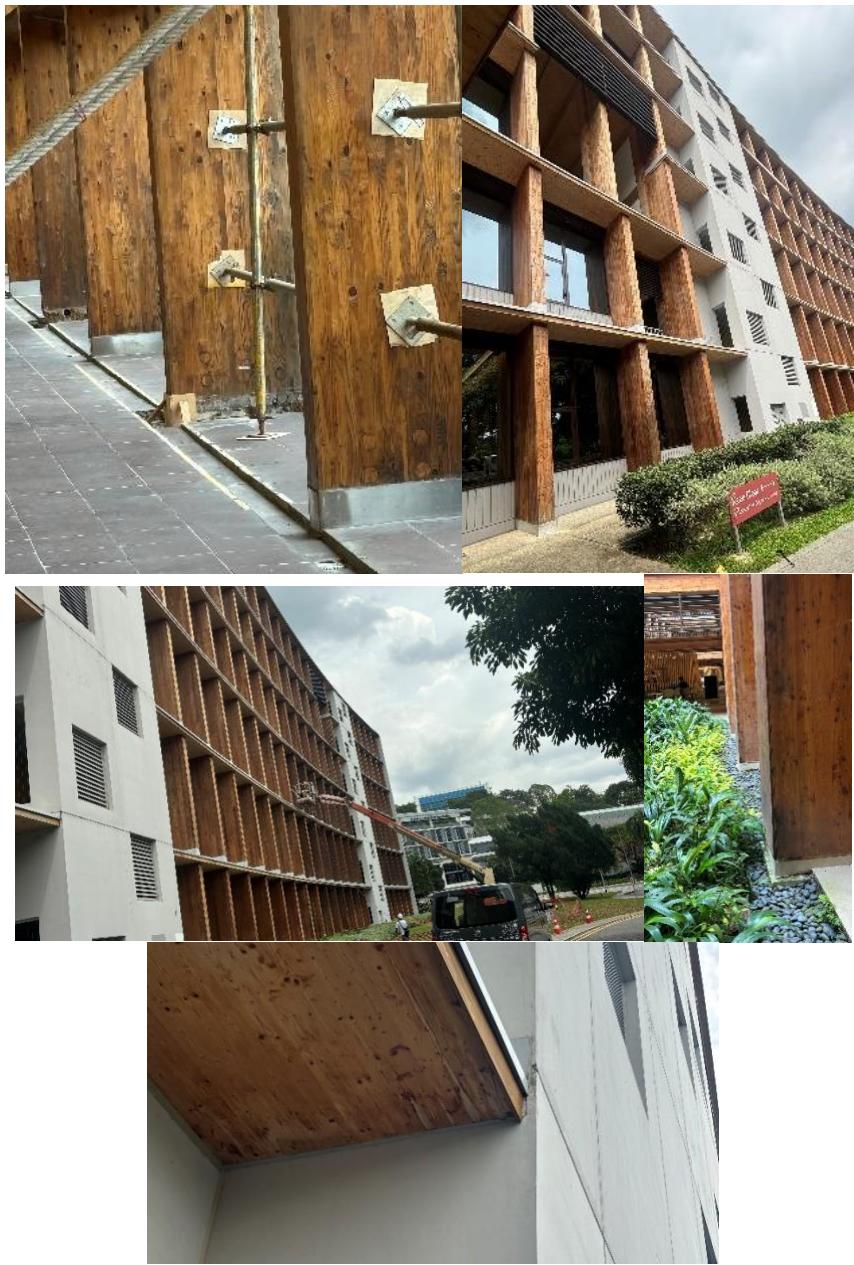
Figure 18: Sections of mass timber building exposed to outdoor environment and maintenance in progress addressing various moisture issues.

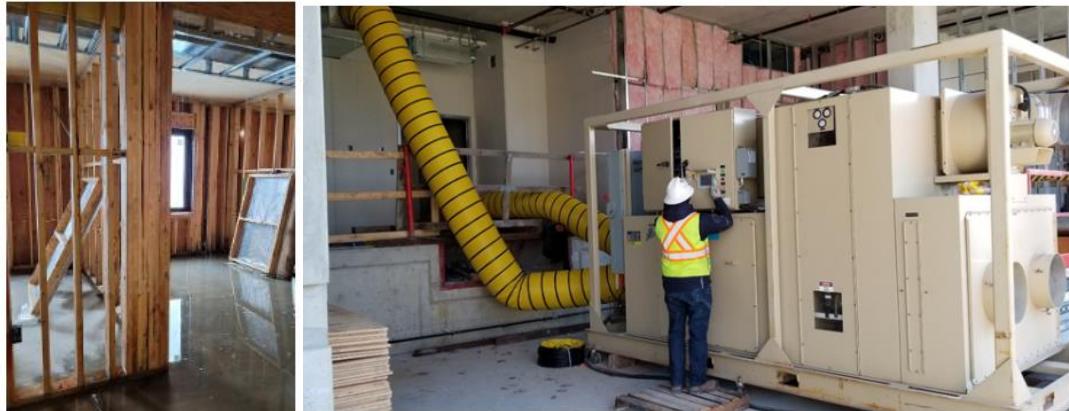
Figure 19: Desiccant drying on construction site.
